Switchgear Commissioning with Partial Discharge Testing

CASE STUDY

LIVE HV was engaged to perform high voltage commissioning testing, including offline Partial Discharge testing, on a new, 35 panel, 12 kV switchgear installation for a power utility.

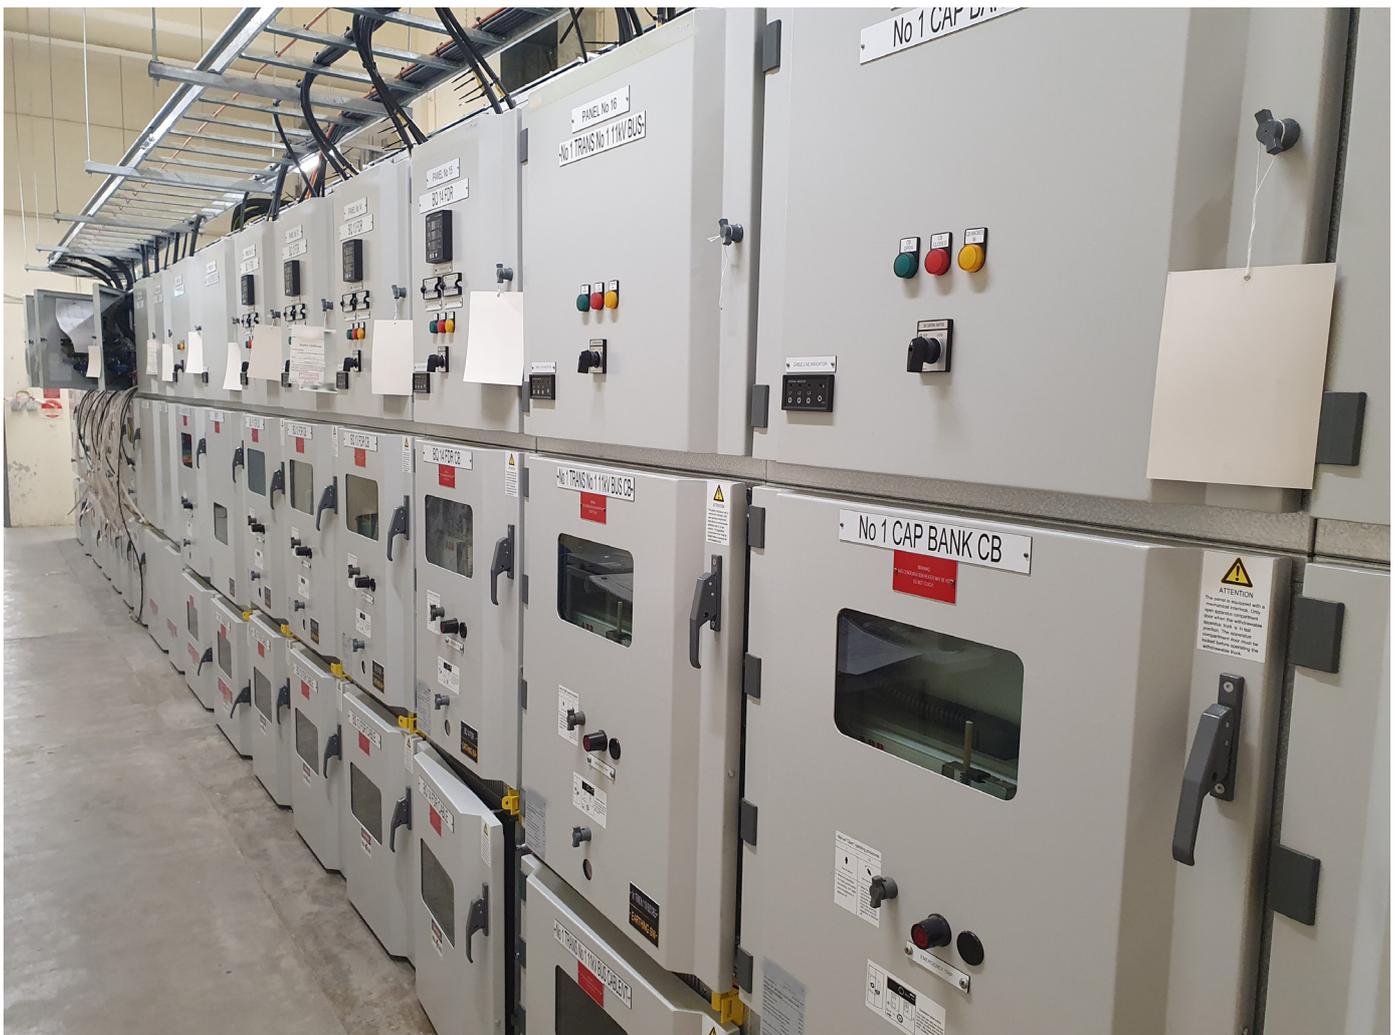
To maximise sensitivity the board was split into four sections and PD tested at 1.1 U_r.

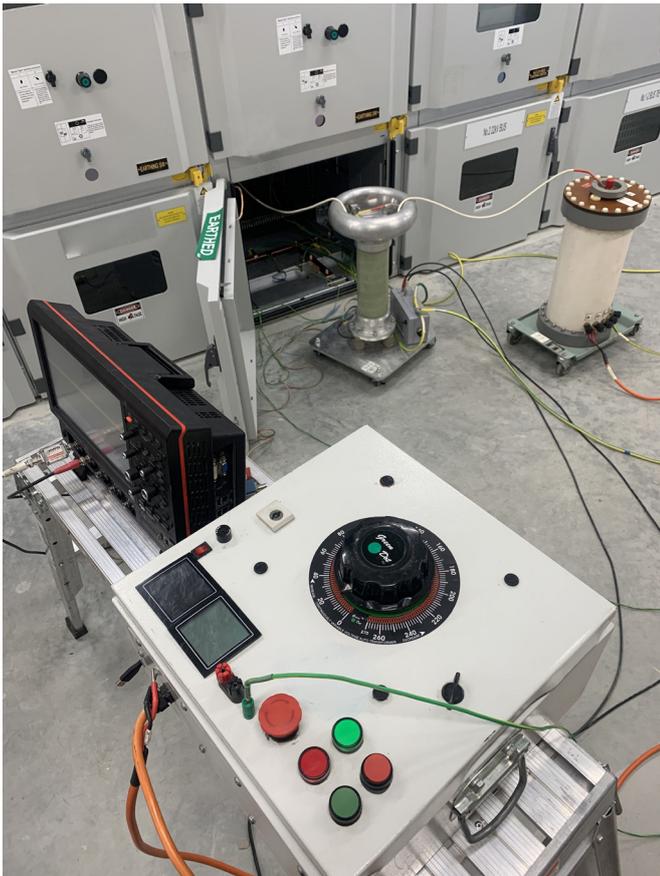
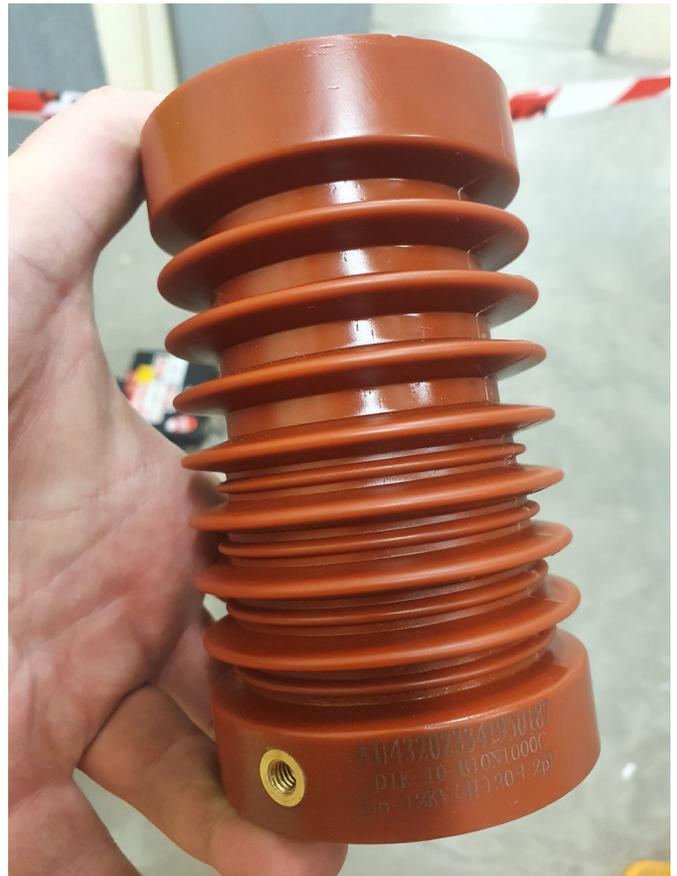
The first step of the pinpointing process was opening the isolators to determine which panel was housing the discharge. Following this, time-of-flight measurements were performed using an array of TEV sensors. The process of elimination identified the offending component as the Blue Phase voltage detector. Once removed from the circuit a retest of the board displayed no discharge.

Further inspection into the circuit discovered an earthing issue on the voltage detector. Had the switchboard been deemed fit for service based on the factory tests, this minor, but not insignificant issue would have gone unnoticed. The component would have continued to deteriorate and led to a failure whilst also presenting a safety hazard.
