# High Voltage Testing Services Water Treatment Plant

### PROJECT DESCRIPTION

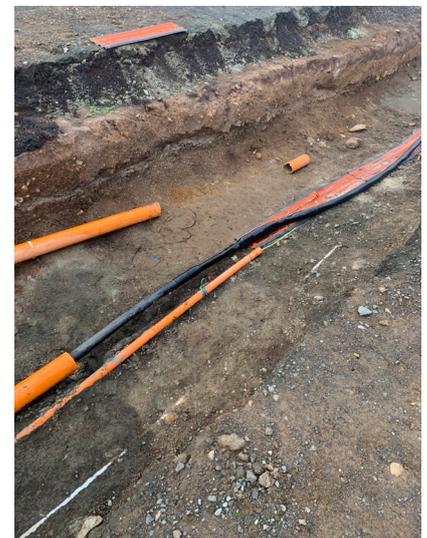
Upon excavation a joint was revealed at the precise location PD had been identified.

*Excavated Joint*

The discharging joint and a small section of cable was removed and replaced with two new joints. Upon testing both of these new joints also had unacceptable levels of PD! As such they were also replaced, and repeat testing showed the cable was now 'healthy'.

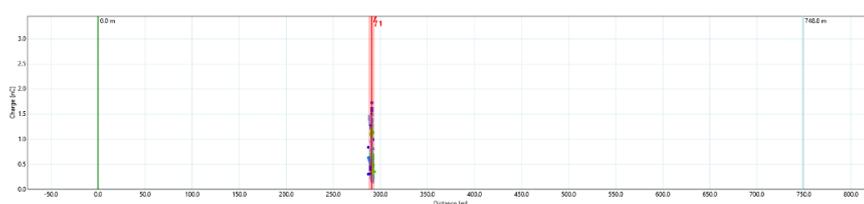
Using time domain reflectometry techniques, it was possible to calculate the location of the discharge. The PD was determined to be midway along the cable and pinpointed with a tolerance of less than 1 metre over a 500-metre cable. Generally, this would indicate a joint at the location, however the customer was unable to confirm a joint due to incorrect schematics. As no joint could be confirmed the testing was stopped due to the high risk of accelerated failure that mid cable PD can pose to a cable. An excavation of the cable was recommended.

*PD Location*

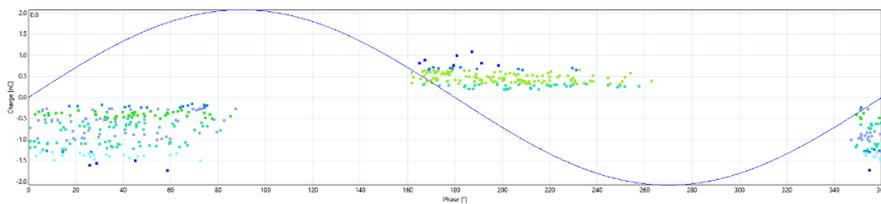
PD and TD testing was performed concurrently so either diagnostic measurement indicating an issue would result in the test being aborted to prevent damage to the cable. The TD test results were acceptable however the PD indicated discharge emanating from within the cable.

PD Phase Pattern

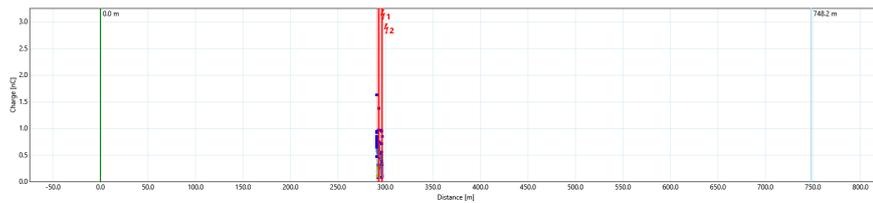
PD Location of First Replacement Joints

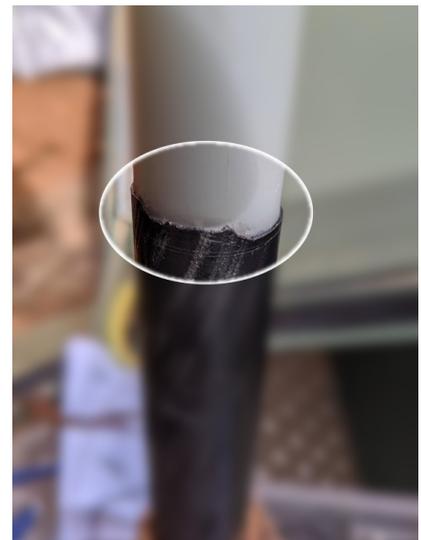
Semi Conductive Layer Cut

An investigation was performed on the replacement joints and found that the semi conductive layer was not cut level and the shear bolt from the cable joint was protruding above the joint sleeve.

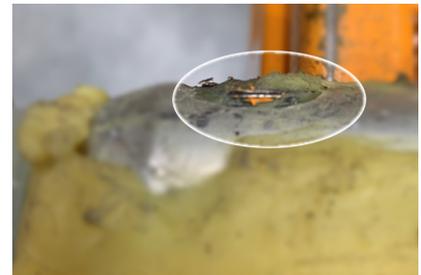
Protruding Shear Bolt
