High Voltage Testing Services GAS PLANT

HV COMPONENT REPLACEMENT

PROJECT DESCRIPTION

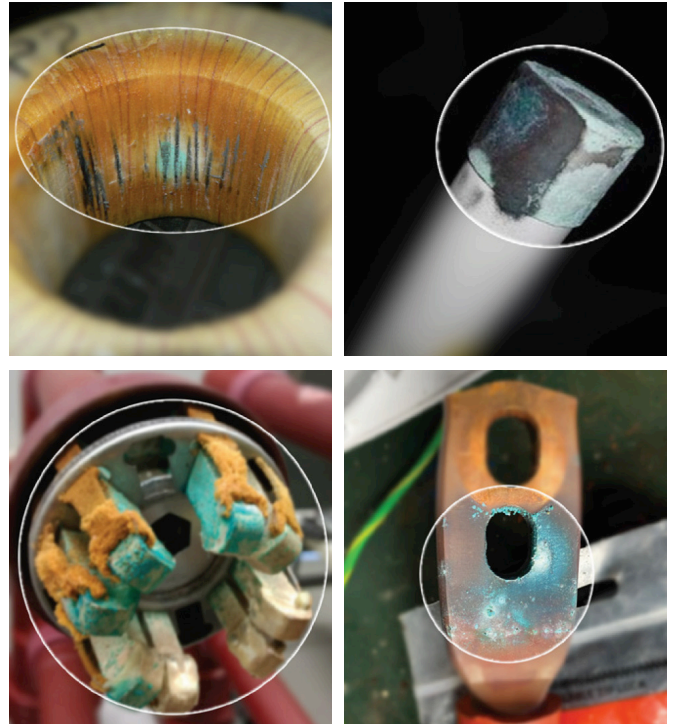
During the initial isolation and inspection of the site assets, corrosion and oxidation were observed and noted on several components inside the switchgear cubicle. A by-product of Partial Discharge is the release of ozone and nitrous oxide, this commonly results in visible corrosion and oxidation on the surface of HV components.

The root cause of this PD was likely high precipitation and faulty cubicle heater.

Corrosion and Oxidisation

Following testing the next step was to address the root causes of equipment degradation and replace the faulty components. To regulate temperature and humidity conditions of the switchgear a new kiosk enclosure and cubicle heater were first on the agenda. Once the enclosure was sourced, the switchgear was installed, with faulty CT's and VT's replaced. The entire unit was then craned into place where repeat testing was performed, confirming that all identified issues with the HV network had been resolved.

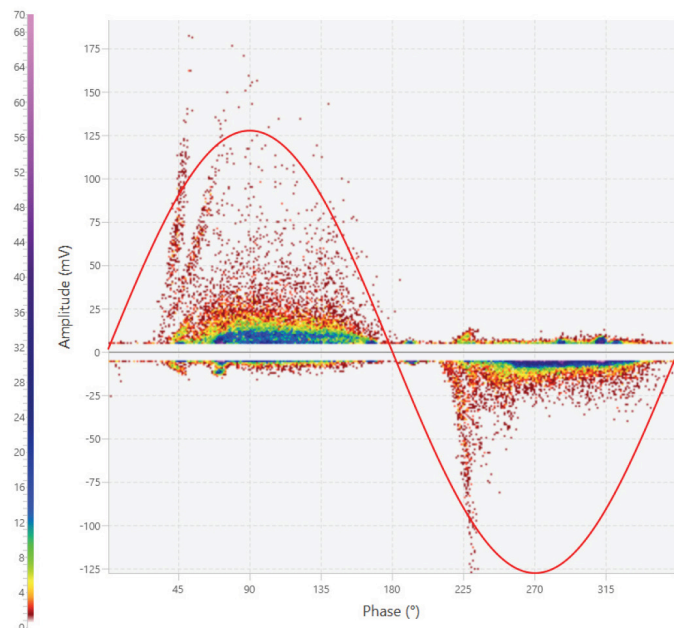
High Voltage PD testing confirmed significant discharge was occurring from multiple locations in the switchgear. Using a combination of PD time of flight techniques, including electromagnetic and acoustic sensors, the offending components were successfully pinpointed. It was determined that the remainder of the switchgear was in good condition with no PD evident.

PD Phase Pattern from discharging switchgear

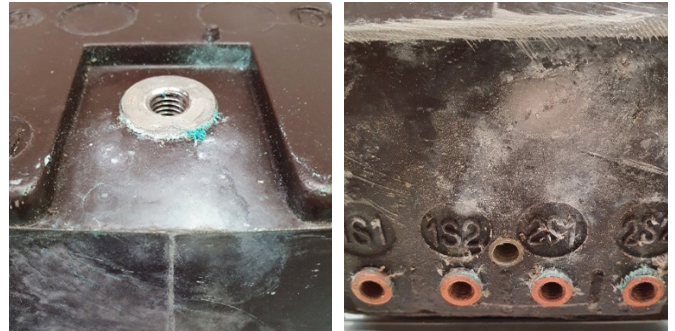
Evidence of discharge
