Transformer Online Partial Discharge Testing

During an online Partial Discharge (PD) survey at a Queensland resort high levels of PD were detected while assessing medium voltage cables. Key location techniques showed the PD was not related to the cable but was emanating from a transformer.

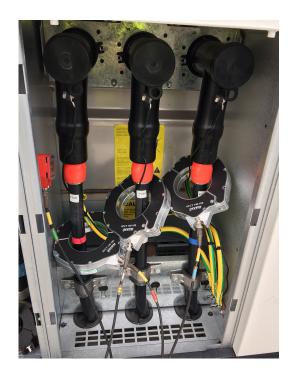
PD measurements were obtained by placing High Frequency Current Transformers (HFCT's) at various Ring Main Units (RMU's) and connecting to the diagnostic testing device.

HFCT's Phase resolved PD pattern

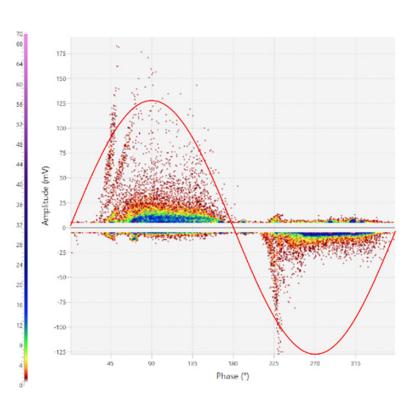
High PD detected on cable network

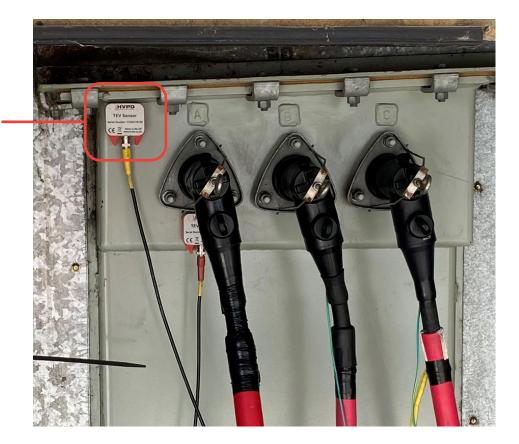
TEV Sensor

Generally internal PD from a transformer will not produce a TEV signal as the tank acts like a faraday cage. TEV signals can emanate from the gaskets however, particularly when the PD is a high level, as was this case.

The transformer was substituted with a replacement while repairs could be made to the original.
