REFCL Options Explained

REFCL Testing and issues identified

High Voltage Testing Services Gas Plant

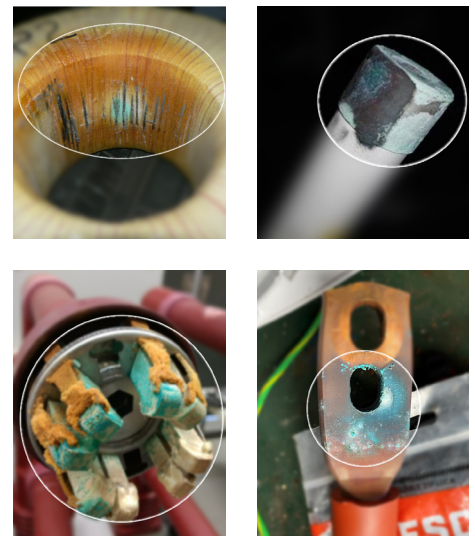
During the initial isolation and inspection of the site assets, corrosion and oxidation were observed and noted on several components inside the switchgear cubicle. A by-product of Partial Discharge is the release of ozone and nitrous oxide, this commonly results in visible corrosion and oxidation on the surface of HV components.

The root cause of this PD was likely high precipitation and faulty cubicle heater.

Corrosion & Oxidisation

- Entire site's condition assessed in 1 day utilising concurrent testing
- Discharging CT's and VT's identified
- Switchgear cubicle heater repaired
- Follow-up testing completed with the site deemed REFCL compliant
- Functionality of the HV network ultimately upgraded

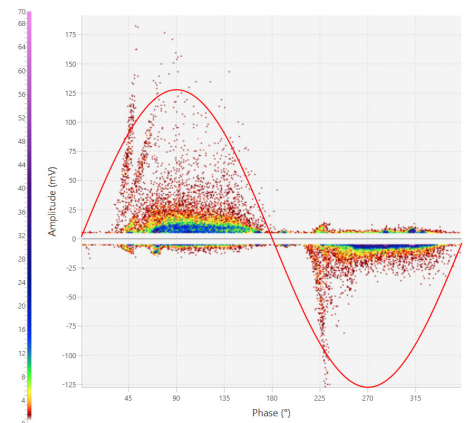
High Voltage PD testing confirmed significant discharge was occurring from multiple locations in the switchgear. Using a combination of PD time-of-flight techniques, including electromagnetic and acoustic sensors, the offending components were successfully pinpointed. It was determined that the remainder of the switchgear was in good condition with no PD evident.

PD Phase Pattern from discharging switchgear

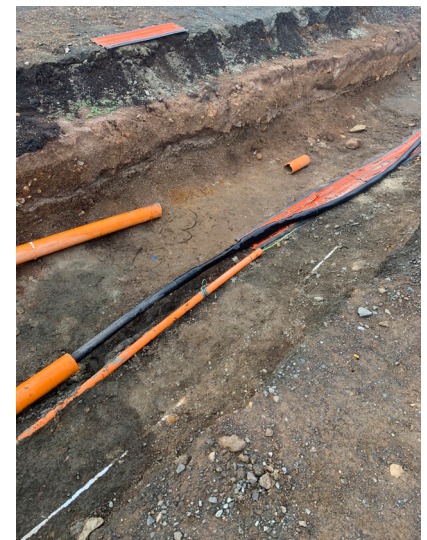
Upon excavation a joint was revealed at the precise location PD had been identified.

Excavated Joint

The discharging joint and a small section of cable was removed and replaced with two new joints. Upon testing both of these new joints also had unacceptable levels of PD! As such they were also replaced, and repeat testing showed the cable was now 'healthy'.

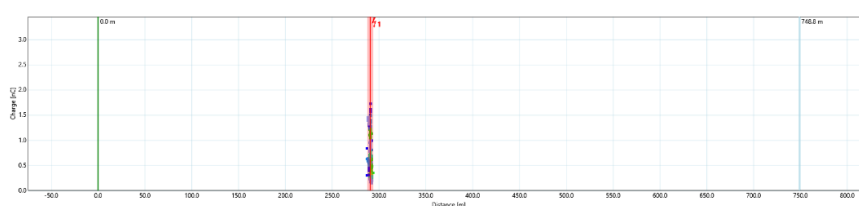
Using time domain reflectometry techniques, it was possible to calculate the location of the discharge. The PD was determined to be midway along the cable and pinpointed with a tolerance of less than 1 metre over a 500-metre cable. Generally, this would indicate a joint at the location, however the customer was unable to confirm a joint due to incorrect schematics. As no joint could be confirmed the testing was stopped due to the high risk of accelerated failure that mid cable PD can pose to a cable. An excavation of the cable was recommended.

PD Location

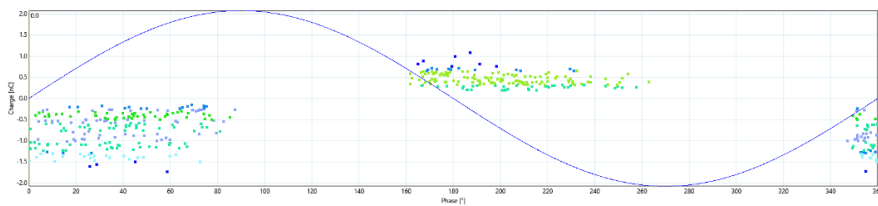
PD and TD testing was performed concurrently so either diagnostic measurement indicating an issue would result in the test being aborted to prevent damage to the cable. The TD test results were acceptable however the PD indicated discharge emanating from within the cable.

PD Phase Pattern

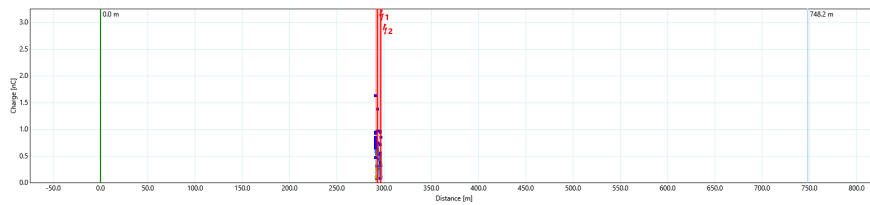
PD Location of First Replacement Joints

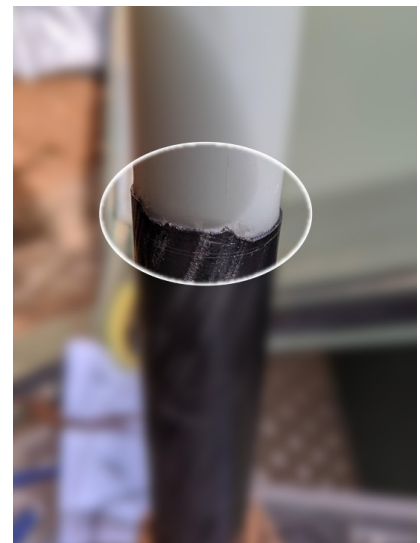
Semi Conductive Layer Cut

An investigation was performed on the replacement joints and found that the semi conductive layer was not cut level and the shear bolt from the cable joint was protruding above the joint sleeve.

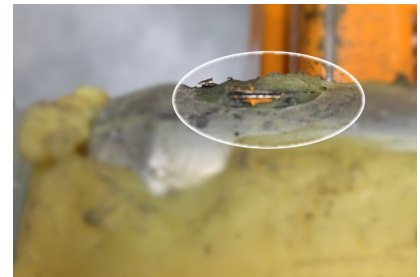
Protruding Shear Bolt

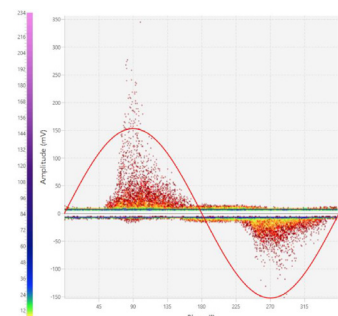
PD was detected from the switchboard which was high in magnitude and incepting below service voltage. Using time-of-flight techniques, the PD was identified as emanating from the bus section. Withstand testing on the switchgear was not performed as it was considered likely to fail during this procedure.

Along with high magnitude PD, the critical factors here are the inception voltage and location. Having PD inception below regular service voltage shows that the asset will be discharging during regular service conditions and be continually deteriorating. The location was also critical, being the bus section of a sealed unit the best option in this case was full replacement of the asset.

Discharging Switchgear

The switchgear was placed back into service with a recommendation that it be replaced as soon as a new asset could be sourced. Remote online PD monitoring was set up to continuously trend the asset's rate of degradation so the customer could be alerted if any significant rise in PD was detected. The customer was able to plan for contingencies should the equipment have failed in the interim.
