REFCL Options Explained

REFCL Testing and issues identified

High Voltage Testing Services Gas Plant

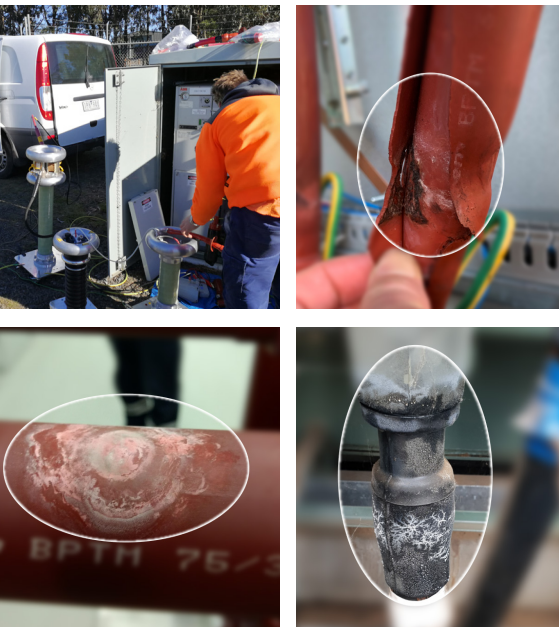
During the initial isolation and inspection of the site assets, corrosion and oxidation were observed and noted on several components inside the switchgear cubicle. A by-product of Partial Discharge is the release of ozone and nitrous oxide, this commonly results in visible corrosion and oxidation on the surface of HV components.

High Voltage PD testing confirmed significant discharge was occurring from multiple locations in the switchgear. Using a combination of PD time-of-flight techniques, including electromagnetic and acoustic sensors, the offending components were successfully pinpointed. It was determined that the remainder of the switchgear was in good condition with no PD evident.

The root cause of this PD was likely high precipitation and faulty cubicle heater.

- Entire site's condition assessed in 1 day utilising concurrent testing
- Discharging CT's and VT's identified
- Switchgear cubicle heater repaired
- Follow-up testing completed with the site deemed REFCL compliant
- Functionality of the HV network ultimately upgraded

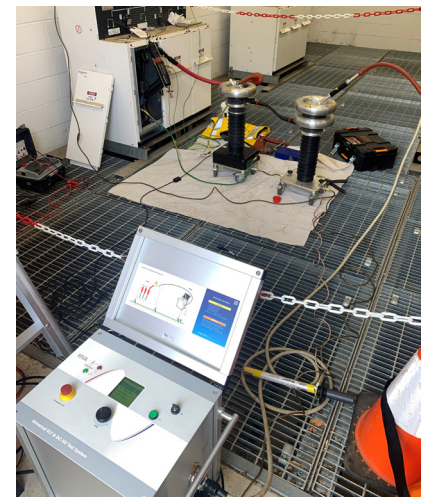
Cable Test Setup

PD and TD testing was performed concurrently so either diagnostic measurement indicating an issue would result in the test being aborted to prevent damage to the cable. The TD test results were acceptable however the PD indicated discharge emanating from within the cable.

Using time domain reflectometry techniques, it was possible to calculate the location of the discharge. The PD was determined to be midway along the cable and pinpointed with a tolerance of less than 1 metre over a 500-metre cable. Generally, this would indicate a joint at the location, however the customer was unable to confirm a joint due to incorrect schematics. As no joint could be confirmed the testing was stopped due to the high risk of accelerated failure that mid cable PD can pose to a cable. An excavation of the cable was recommended.

Upon excavation a joint was revealed at the precise location PD had been identified.
